Load control frequency injection cell structure-borne noise attenuation

David Borgeaud

Environmental Resources Management Australia Pty Ltd, Brisbane, Australia

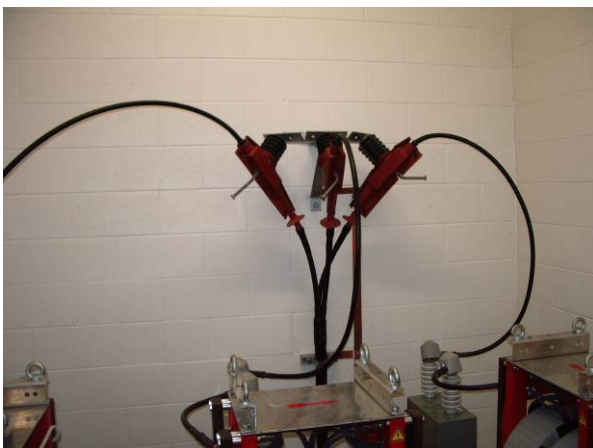
Power cables associated with the LCFI cell equipment were mounted directly on the rear wall (common wall to the office) of the FIR as shown in Figure 3.

Figure 3. LCFI cell power cables mounted on FIR wall

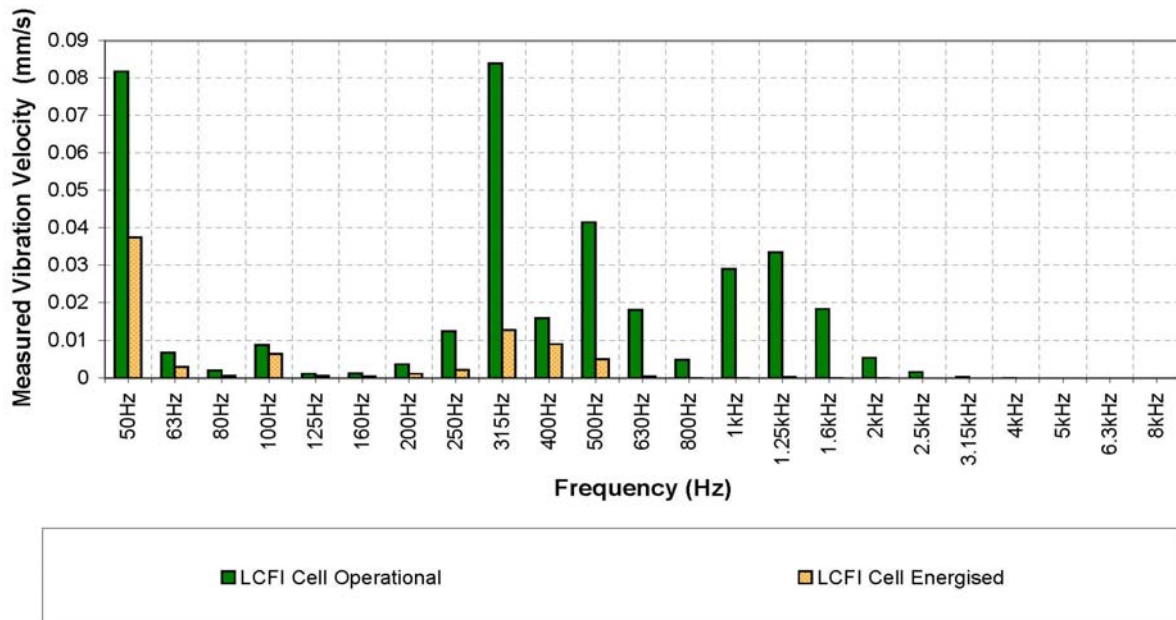
Initial measurements were undertaken to gauge the extent of the noise problem. Figure 4 shows the FIR vibration level spectrum in one third octave bands with the LCFI cell operational and energised. Measurements showed significant vibration levels in the 50Hz and 315Hz third octave bands when the LCFI cell was operational (ie. sending signal). The 315Hz band contains the injection frequency of 283Hz. Vibration was also present to a lesser extent from 400Hz up to 2kHz. The initial measurement was taken in the vertical

plane with the accelerometer located on the 'C' section beam directly below one of the inductor coils.

Figure 4. LCFI cell vibration levels in FIR

It was found that when the LCFI cell was only energised (i.e. not operational), the vibration 1/3 octave band components at 315Hz and above were significantly reduced. The vibration level at 50Hz was also approximately halved (0.037 mm/s compared with 0.083 mm/s). While the 50Hz vibration level appeared significant, it was expected that the A-weighted noise level spectrum would show less 50Hz energy and highlight the mid-frequency noise levels.

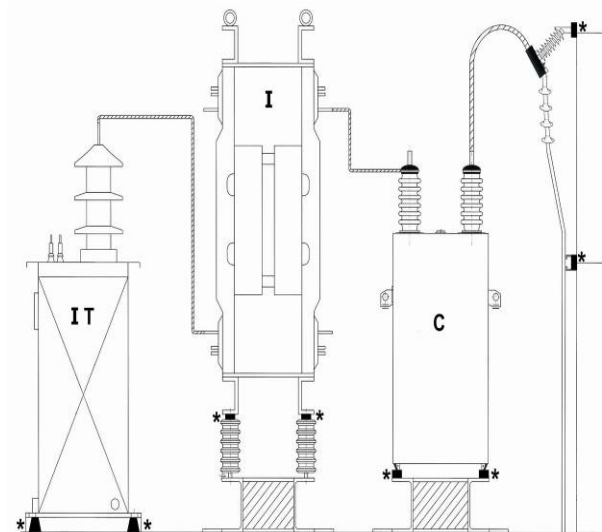
The locations of the isolators are shown in Figure 5.

* RUBBER VIBRATION ISOLATORS

Figure 5. LCFI cell equipment vibration isolator locations (Isolating transformer (IT), Inductors (I), Capacitors (C))

- Isolating transformer (270kg) - 4 off, double deflection rubber mounts (max. load 400kg);
- Inductors (coils) (212kg) - 12 off, medium stud mounts (max. load 312kg);
- Capacitors (56kg) - 12 off, soft stud mounts (max. load 64kg);
- Cable Unistrut support (9kg est.) - 2 off, double deflection rubber mounts (max. shear load 10kg); and
- Cable bracket (27kg est.) - 3 off, double deflection mounts (max. shear load 33kg).

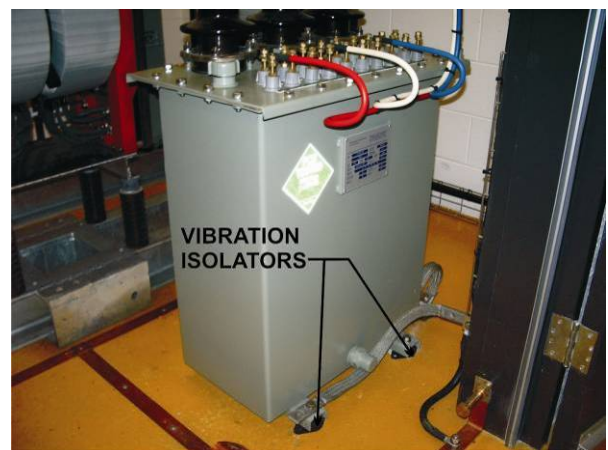
Figures 6, 7 and 8 show the isolators installed on the LCFI cell equipment.

Figure 6. Isolating Transformer with vibration isolators installed

- Double deflection rubber mounts had M10 and M8 threaded female;
- Stud mounts had M10 and M8 threaded male extending each side of rubber element;
- The double deflection rubber isolators could be mounted under the transformer using a steel plate to spread the load across the two edges of the existing channel section base. Alternatively on site, it was found that the isolators could fit inside the channel section while still maintaining clearance between the floor and the channel section, which proved to be an easier installation solution. These isolators were bolted to the transformer, but were not bolted to the floor as the weight of the transformer combined with the friction grip of the rubber isolators provided a stable system.
- Flexible earth straps were used to connect the equipment to the earth system (in lieu of the previous solid copper elements).

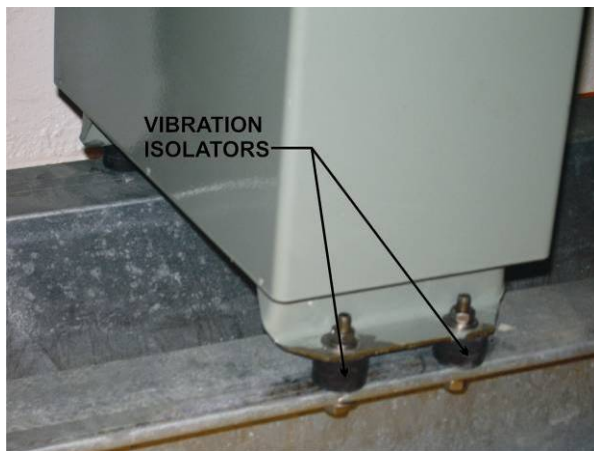
Figure 8. Capacitors with vibration isolators installed

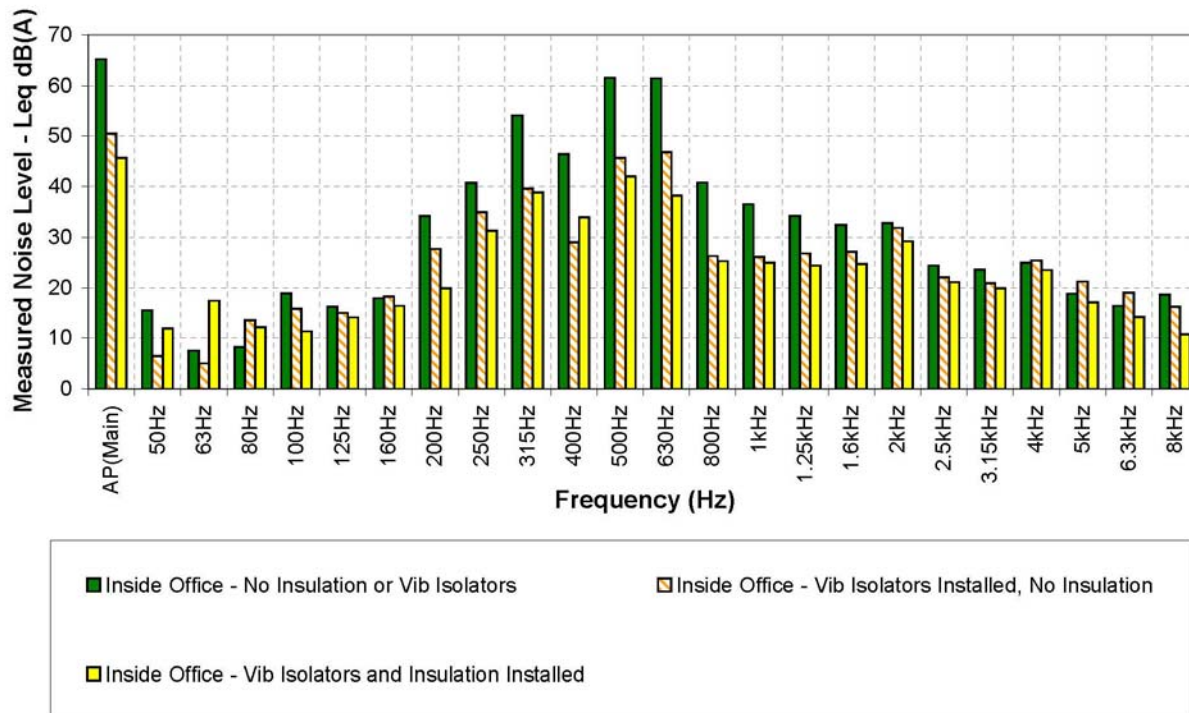
Figure 9 shows the office noise level spectrum in one third octave bands with the vibration and insulation treatments installed. Some irregularities in the data were observed (eg. higher levels after some treatments than prior to treatment at selected frequencies). This was caused by room modes in the receiving space, differences in measurement locations, and also some variation in background noise levels in the office. However the significant energy in the mid frequencies provides a clear representation of the before and after effectiveness of the treatments. The peaks in spectrum at 315Hz, 500Hz and 630Hz correlate well with the signal frequency and harmonics (283Hz and 566Hz).

Figure 9. LCFI cell noise levels in office
