A case study on the transmission loss suite in the University of Technology Sydney

Qiaoxi Zhu

University of Technology Sydney, Sydney, Australia

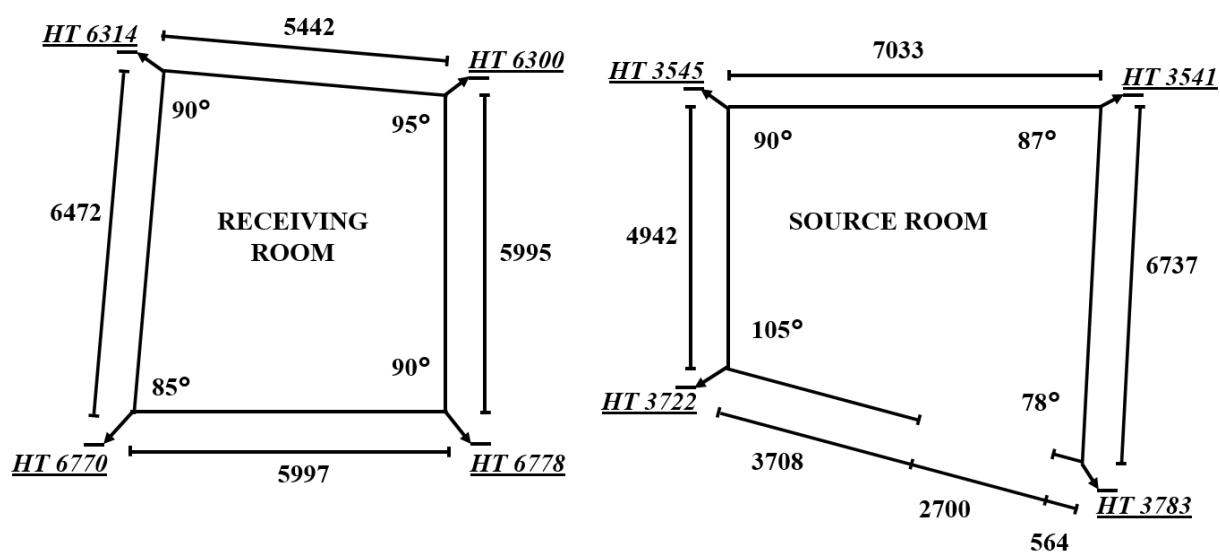
Figure 1: Geometry of the floor of the source room and the receiving room, where HT means the height of the wall from floor level and all units are in millimetre

The transmission loss suite in UTS consists of two adjacent reverberant rooms with a test opening between them, in which the test element is inserted. Each reverberation room comprises an inner shell of concrete walls forming four walls and a roof, all mounted on a designed concrete floating slab floor which in turn is floated on correctly loaded anti-vibration mounts to reduce the inference from surround sound and vibration. The volume of the source room is approximately 147 m^3 with a total surface area of about 176 m^2 . The volume of the receiving room is around 232 m^3 with a total surface area of approximately 247 m^2 . The test opening is 3.37 m wide and 2.99 m high. The source room has two double-leaf triple seal access doors and the dimensions of the doors are 2.50 m wide and 2.54 m high. The receiving room has two single-leaf triple seal access doors and the dimensions of the doors are 0.98 m wide and 2.54 m high. Figure 1 shows the geometry of the source room and the receiving room, where HT means the height of the wall from floor level and all units are in millimeter. Figure 2 shows two photos inside the source room and Figure 3 shows two photos inside the receiving room. In this measurement, the source room and receiving room suspend three and four transparent perspex plane panels, respectively, as diffusers from the roof of the room. The size of all the panels is $1.50 \text{ m} \times 1.20 \text{ m} \times 0.01 \text{ m}$. The structural opening for measuring the transmission loss is approximately 3.83 m wide and 2.99 m high with a clear opening 3.37 m wide and 2.99 m high. Figure 4 shows three photos of the test opening with and without the test wall.

The position of the microphones and the sound sources used in the measurements are listed in Tables 2 and 3. The origin of the coordinate is separately at the left top corner of the floor of the source room at the right bottom corner of the floor of the receiving room in Figure 1. The sound sources in the source room are for the sound pressure level measurement and the sound sources in the receiving room are for the equivalent absorption area measurement. The sound source positions were qualified following Annex D of ISO 10140-5:2010.

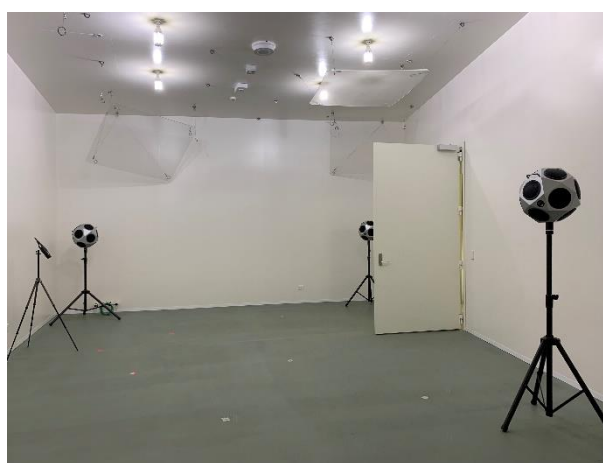
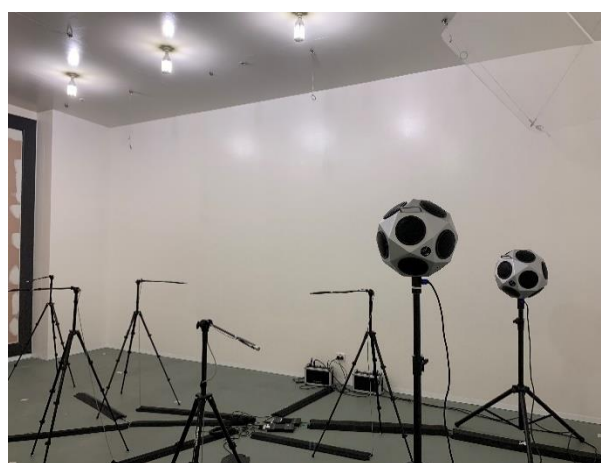
Figure 2: Photos of the source room at UTS (a) ceiling with transparent diffusers and (b) ground with testing sources and microphones

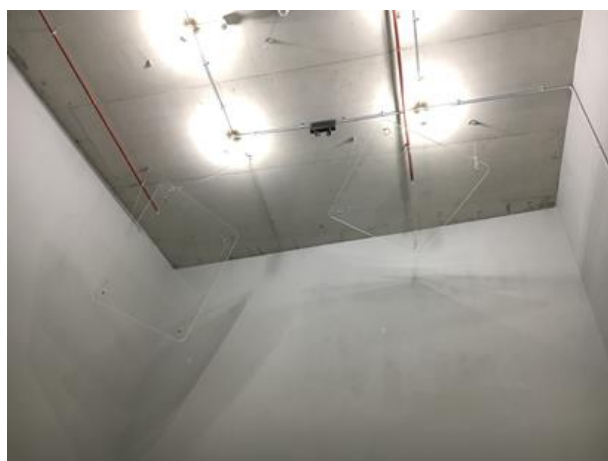
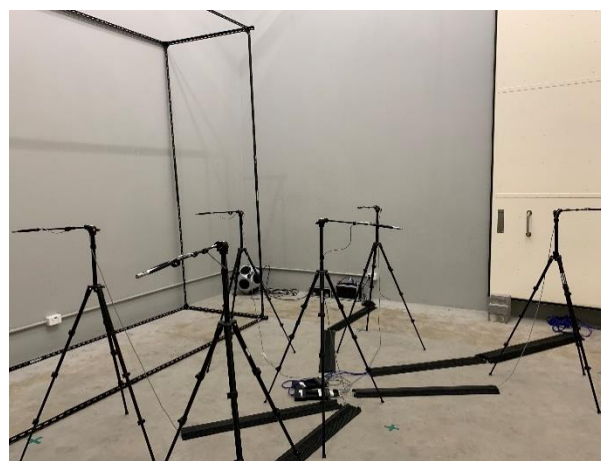
Figure 3: Photos of the receiving room at UTS (a) ceiling with transparent diffusers and (b) ground with testing sources and microphones

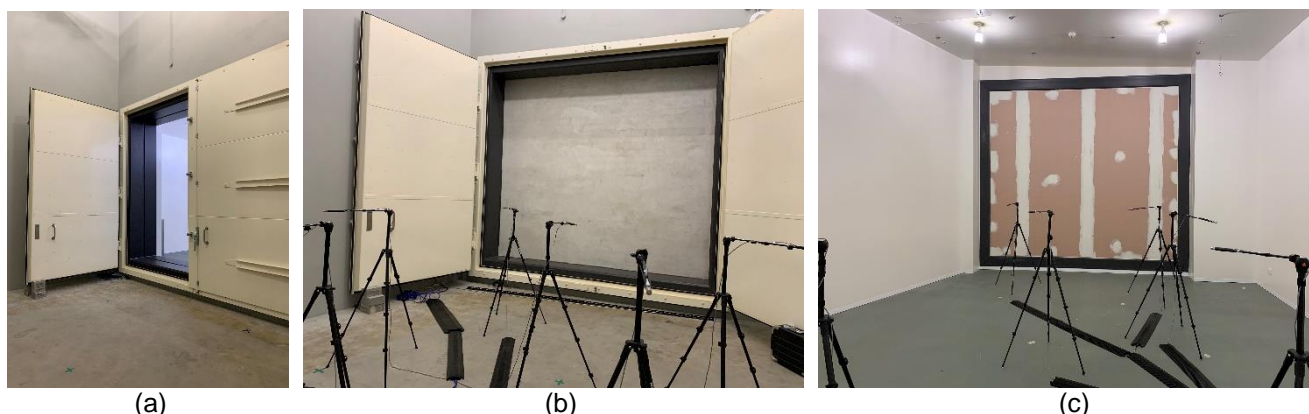
Figure 4: Photos of the test opening (a) empty (b) with test wall viewed from the receiving room (c) with test wall viewed from the source room

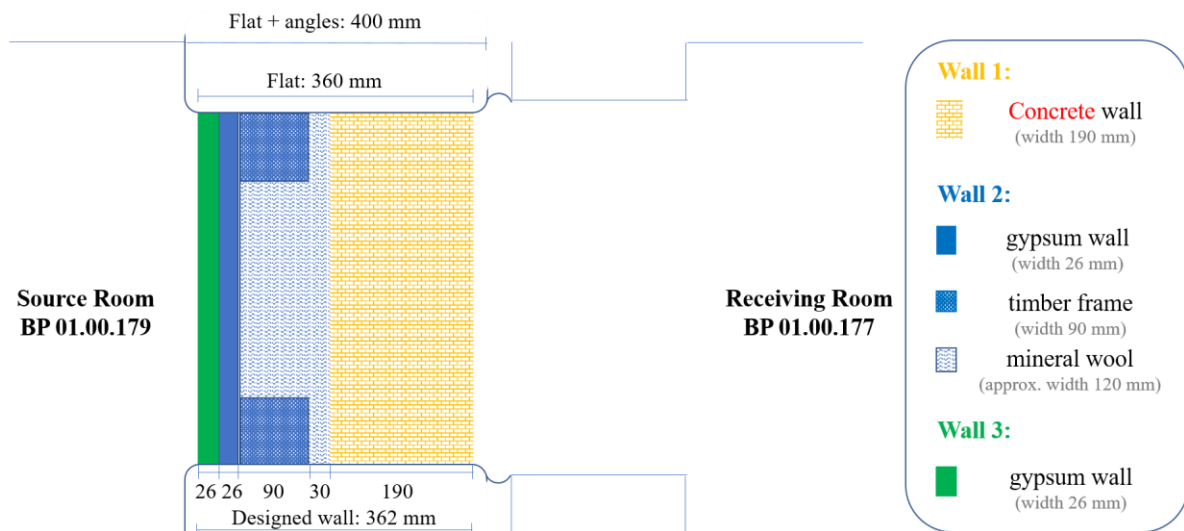
Figure 5: Geometry of the test wall at the test opening, which is composed of three layers

Figure 5 shows the test wall, a typical heavyweight masonry wall following ISO 10140-5, A.2.2.1.3. It consists of a concrete brick wall, having a mass per unit area of approximately 400 kg/m². On one side, an independent lining is constructed comprising four layers of 13 mm plasterboard supported on a 90 mm timber frame that is not connected to the wall. The cavity between the wall and the lining is 120 mm wide and contains mineral wool. The 190 mm thick concrete block wall was installed to steel-framed test opening, with a skim coat of render to external face and joints caulked all around. The insulation layer was filled with the 75 mm Fibretech 350 rock wool board with a nominal density of 60 kg/m³. The plasterboard sheets were staggered 13 mm Fyrchek with joints caulked all around.

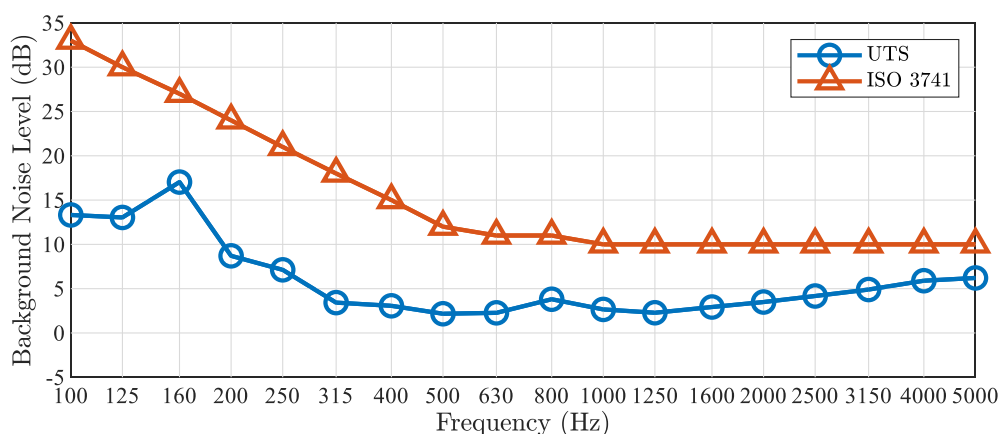
Figure 6: The averaged values of the background noise level of the receiving room measured by Brüel & Kjær 4942 1/2" microphone and the absolute criteria for the background noise specified in Table 2 of ISO 3741

The background noise was measured at the six microphone positions in the receiving room (shown in Table 3) on 30 January 2020. Following Chapter 4.3 in ISO 10140-4, the measured background noise includes noise from outside the test room and electrical noise in the receiving system. The averaged measured values (arithmetic mean value of the values at the six microphone positions) in the 18 one-third-octave bands and the absolute criteria for background noise specified in Table 2 of ISO 3741 are shown in Figure 6. The measured noise level fully meets the absolute criteria for the background noise. The averaged overall background noise level of the sound pressure level in the whole frequency band is 21.3 dB and 15.5 dBA.

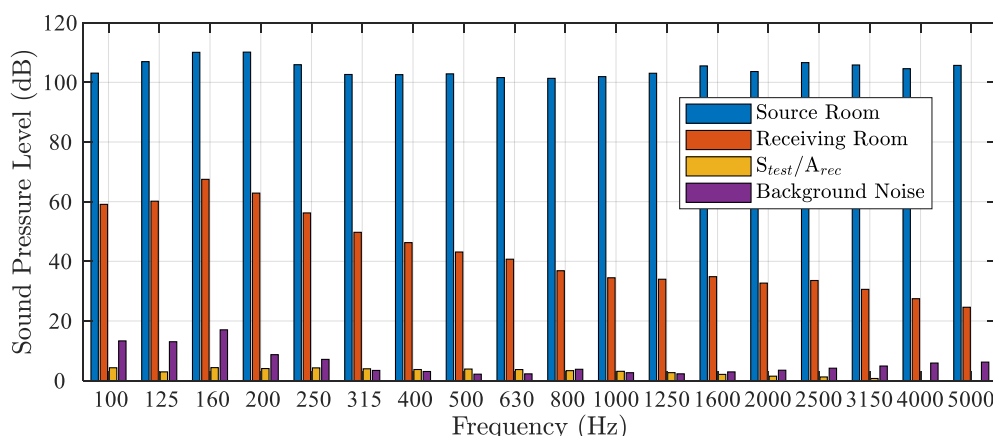
Figure 7: The energy average sound pressure level in the source room and the receiving room, the spatially averaged background noise in the receiving room, and the ratio of area of the test opening and the area of the equivalent sound absorption

where L_1 is the energy average sound pressure level in the source room, L_2 is the energy average sound pressure level in the receiving room, S is the area of the free test opening in which the test element is installed, and A is the equivalent sound absorption area in the receiving room. Their values in the one-third-octave bands are presented in Figure 7, and the corresponding sound reduction index is presented in Figure 8. The background noise level is more than 18 dB below the level of signal and background noise combined at each frequency band, so that the observations in the receiving room are not affected by the background noise. The minimal sound reduction is 47.1 dB in the one-third-octave band centred at 160 Hz, and the maximal sound reduction is 83.9 dB in the one-third-octave band centred at 5000 Hz. The weighted sound reduction index (R_w) of the test wall is 66 dB with spectrum adaptation terms (C and C_{tr}) being -1 dB and -6 dB for the A-weighted pink noise spectrum and urban traffic noise spectrum, respectively. The sound transmission class (STC) of the test wall is also 66 dB.

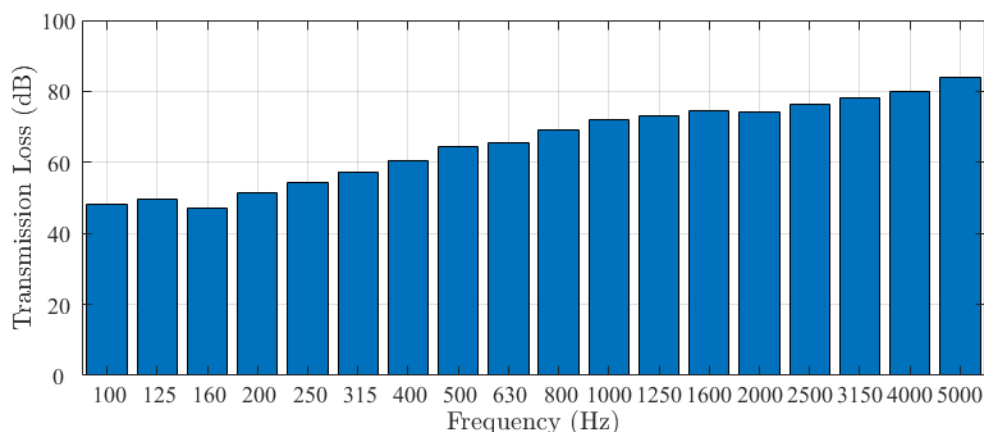
Figure 8: The transmission loss of the test wall versus the frequency

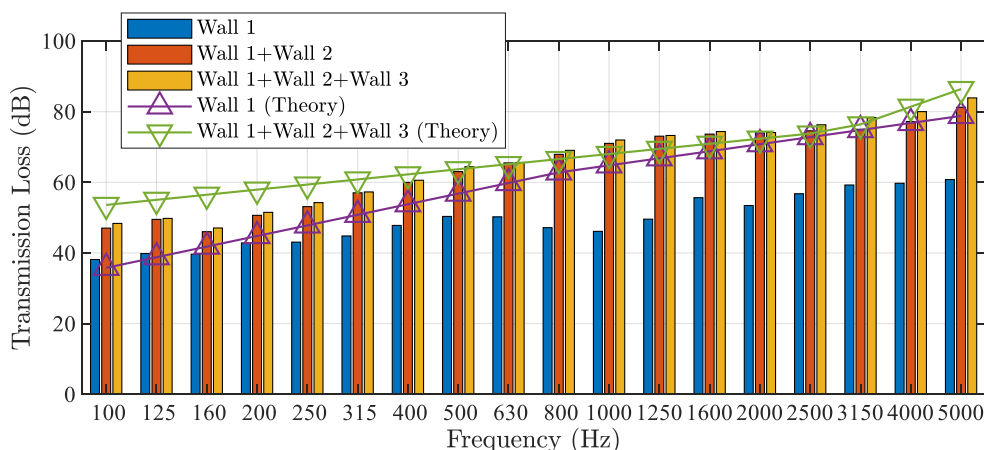
Figure 9: Transmission loss under different test wall conditions, with the theoretical estimations as reference

The intermedium results of the transmission loss with different wall setup are presented in Figure 9 with reference to the theoretical estimations calculated using ENC software (ENC, 2010). The rating of the transmission loss is reported in Table 5. The sound transmission loss improves with the increased layers of walls.
