## Gym Noise Reduction: Two Case Studies

### ABSTRACT

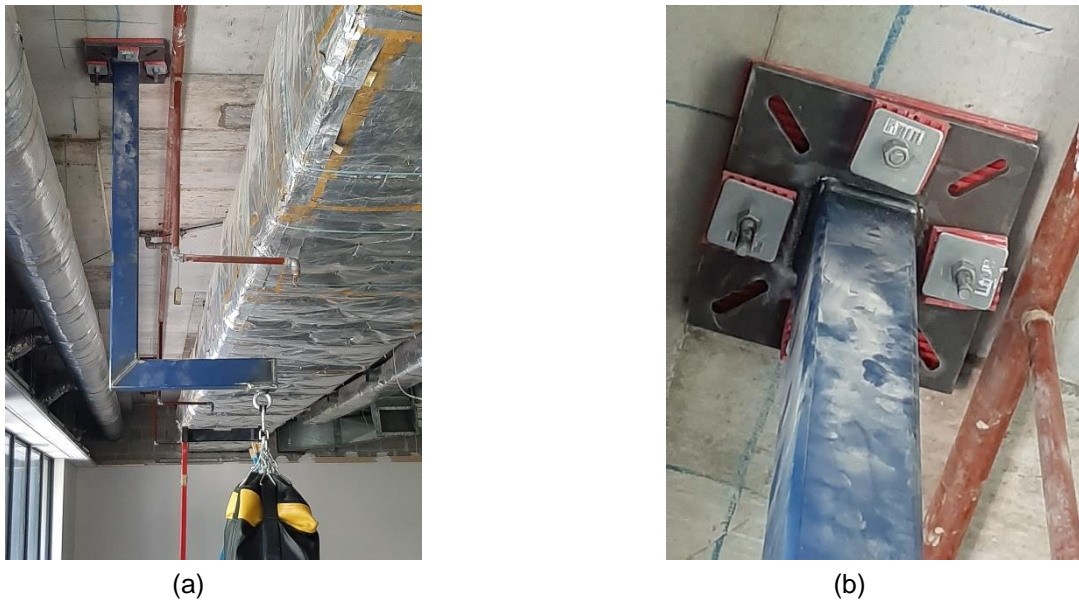
The dropper installation for the first series of in-situ tests is shown in Figure 4. Note the uneven loading of the isolation pads created by the moment arm of the dropper.

Figure 4: Prototype dropper design and isolation
